# rereadings2

**interior architecture  
and the design principles  
of remodelling  
existing buildings**

## Fashion Center Building

**Designer**  
George Ranalli

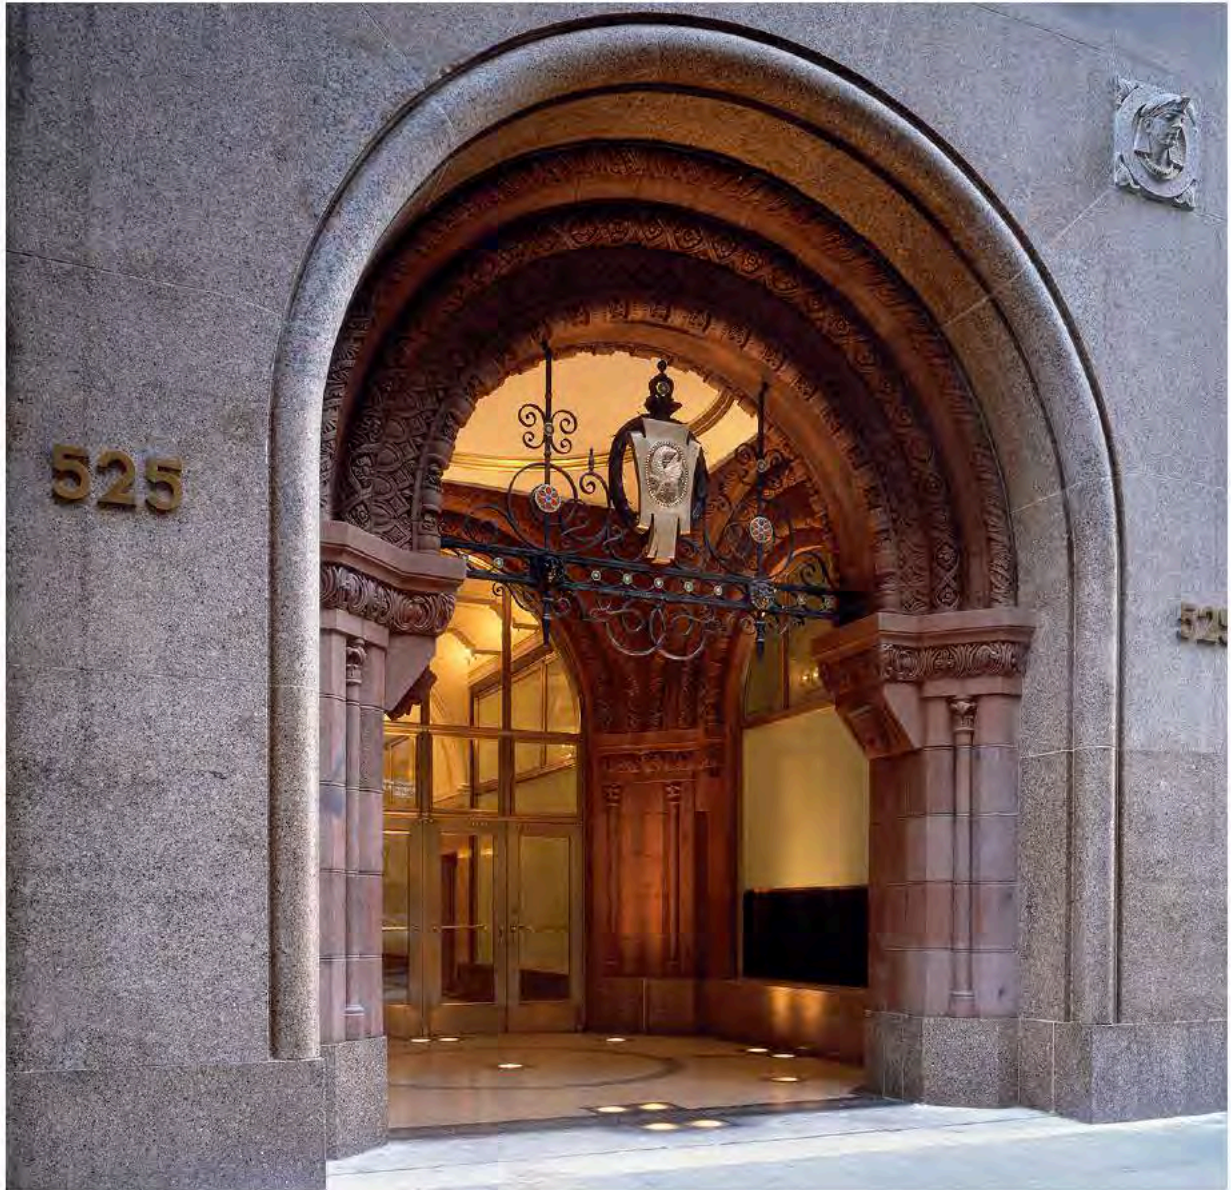
**Figure 3.69** The original portico entrance was exposed in the renovations. Existing elements were repaired and cleaned.

One of the first interventions that Ranalli undertook on the building was the removal of the front doors. He did this in order to reinstate the original portico, in the past

sealed off and hidden behind earlier works to the façade. Drawing on influences derived from the previous surfaces of the space, new terrazzo flooring was laid. Existing and previously hidden terracotta details, including a frieze of animals, were exposed, cleaned, repaired, and where appropriate copied for new pieces to be made and inserted to replace elements of the existing portico that had been lost or removed. Existing columns and capitals were also repaired or restored. A wrought iron grill, in the arch of the portico, was cleaned and repainted. Subtle lighting, set into the new floor, guided the visitor towards a new set of bronze entry doors, and into the main hall.

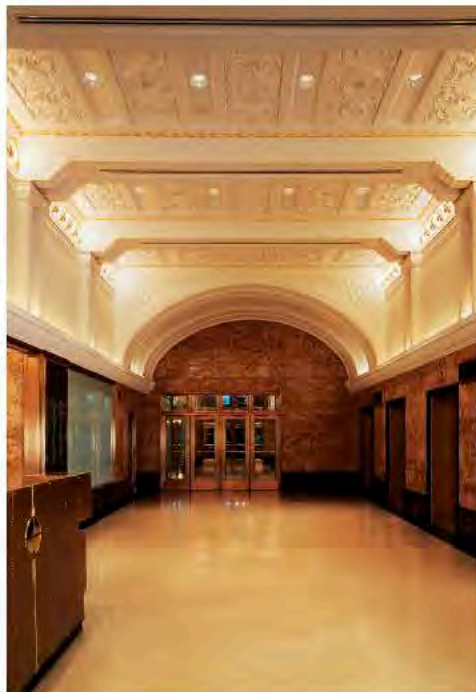
**Figure 3.70** New lighting was carefully considered and discretely hidden in the cornice in order to illuminate the impressive existing ceiling.

In the lobby, modern lighting was hidden inside original fixtures that illuminated the dramatic beauty of the recreated floral plaster cast ceiling. New ornamental paired plaster columns were made, and set upon a subtly lit existing frieze. Each column was topped with an architrave edged in gold leaf. The pale ceiling surfaces were contrasted with restored cream and purple marble walls, accented with delicate gold and black edges. A new bronze reception desk, positioned alongside a set of restored bronze window frames, heating grilles, and elevator doors, introduced a striking contemporary element to the old lobby. These elements clearly articulated how the past had influenced the new contemporary intervention.

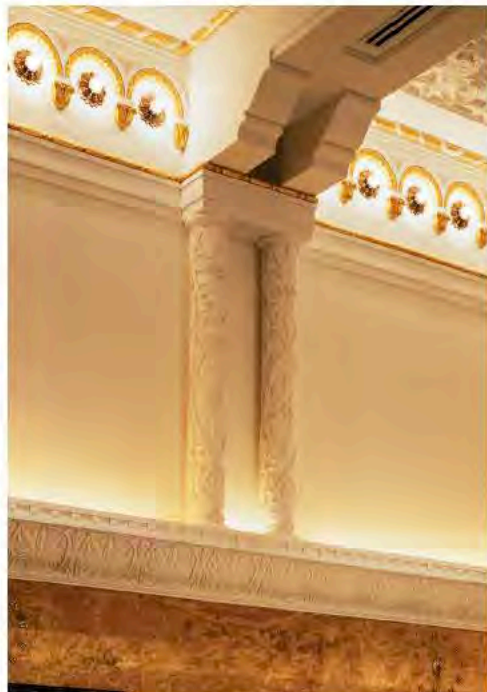
**Figure 3.71** The edge of gold leaf on the new plaster columns was subtly picked out with the new lighting.
